Degradation of Cultivated Soils in a Semiarid Area of Greece

Sgouras Ioannis and Floras Stamatis

National Agriculture Research Foundation (N.Ag.Re.F.)
Institute For Soils Mapping And Classification (I.S.Ma.C.)
1, Theophrastos str., 41335 Larissa, Greece,
Tel. +30-41-660570, Fax: +30-41-660571, E-mail: nagref@hol.gr

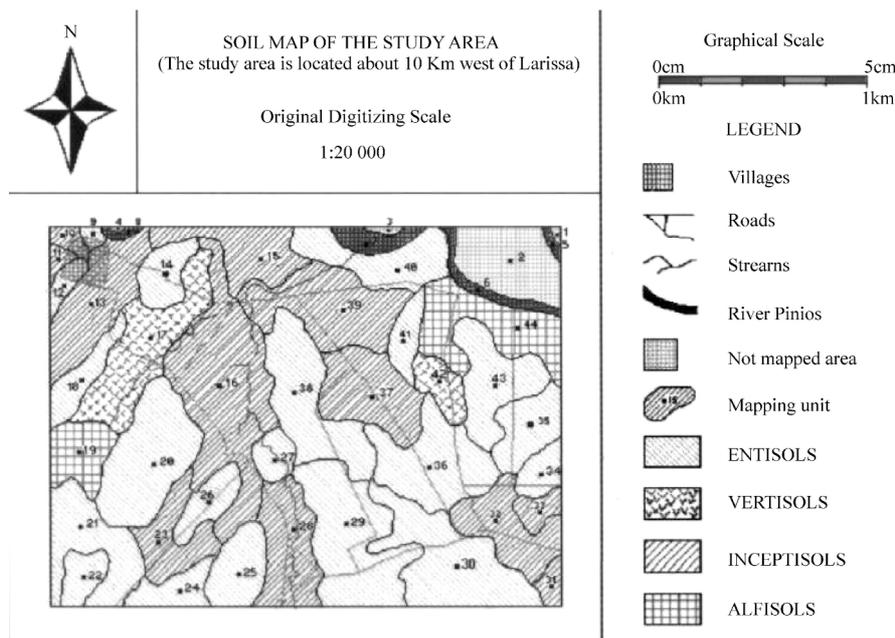
Fig.1 Digital soil map of the study area with soil mapping units, urban areas, road and drainage network layers upon it

The necessary information's for estimating the relationship between slop inclination and surface erosion came up in a preliminary stage from field observations, experimental measurements, former studies, empirical information and remote sensing techniques. Detailed soil survey was conducted in the study area (Fig. 1) and soil auger holes together with soil profiles were described and sampled, (Soil survey staff, 1993 and soil conservation service, 1997).

The intensity of the rain is particularly important as an erosivity parameter, because it is a feature of the rainfall, which in addition to amount can be recorded by conventional meteorological stations. The climate of the area considered Mediterranean (arid to semiarid) and the soils are classified as belonging to the orders of Entisol, Vertisols, Inceptisols and Alfisols, (Fig. 1).

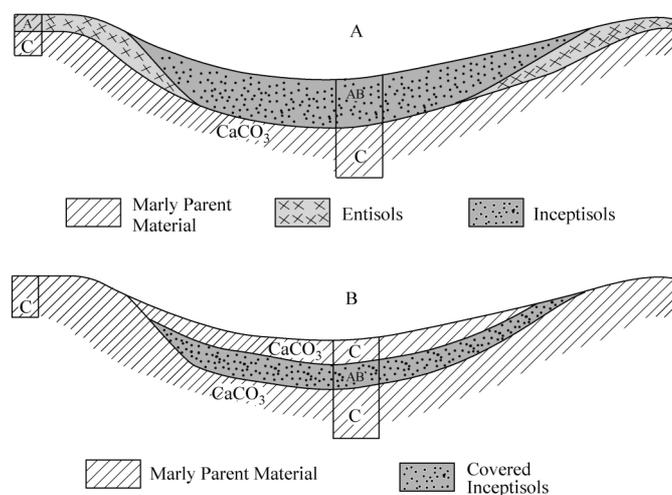
Fig.2 Erosion between hills A and B in the study area

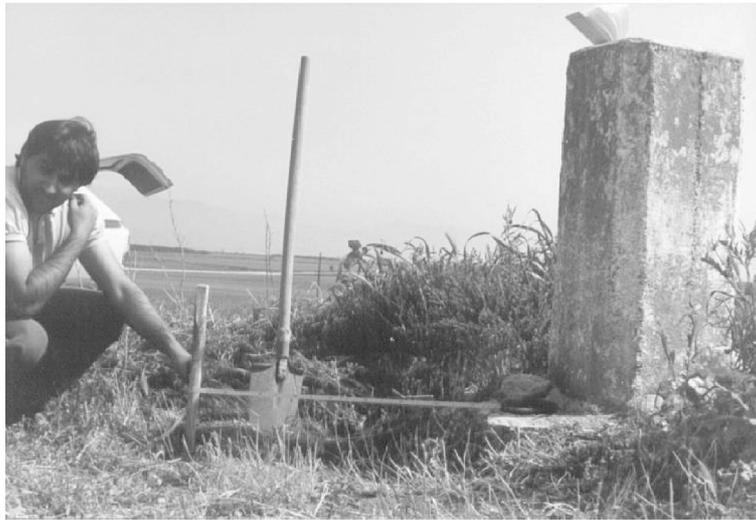
Fig.3 Removal of soil material around the topographical posts

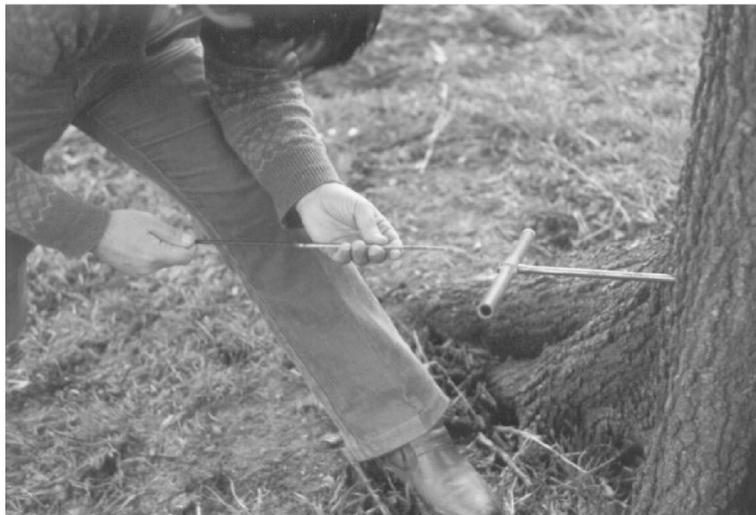
Fig.4 Estimation of the degree of soil erosion from the tree age and the depth of the removed soil material, which can be calculated from the height of the exposure of the tree roots

Describing natural and artificial soil profiles helped in estimating macroscopically the degree of soil erosion, from the exposure or not at the soil surface of the underlying soil horizons. The exposure at the surface of the underlying horizons or parent material may be very useful in estimating the degree of erosion (Fig. 2). Other signs of the degree of erosion are the removal of soil material around the topographical posts (Fig. 3) and the exposure of the roots of the trees above soil surface (Fig. 4). For instance in one topographic post the today's surrounding soil surface is 15 cm below the base of the post, which means that a soil volume of 15 cm depth has been removed since the topographic post was constructed in 1975. If we calculate the erosion rate we shall find that the depth of the lost soil material reaches to 5mm/year ($125\text{mm}/25=5\text{mm}/\text{year}$) or 5m^3 of soil material per year or $75\text{ton} \cdot \text{ha}^{-1} \cdot \text{y}^{-1}$.

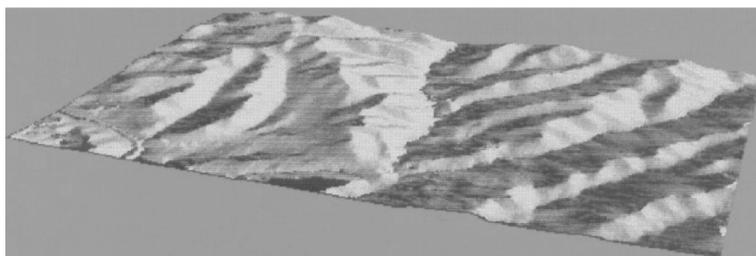
Fig.5 DTM image of the study area seen from NW. Pinios river is flowing at the lower left hand. Relief and topography is quite well represented in this image

From the processed satellite images lots of information was exacted concerning the physiographic elements of the study area. The DTM model was very useful in acquiring a general view and idea, how is the physiography of the study area and so making more easy to compare the relief and topography shown clearly in the DTM images with the rest of the extracted images and fieldwork data, (ESRI In., 1997).
