## DESIGN OF QUEENSLAND ROAD INFRASTRUCTURE FOR HIGH RISK ENVIRONMENTS

### Abstract

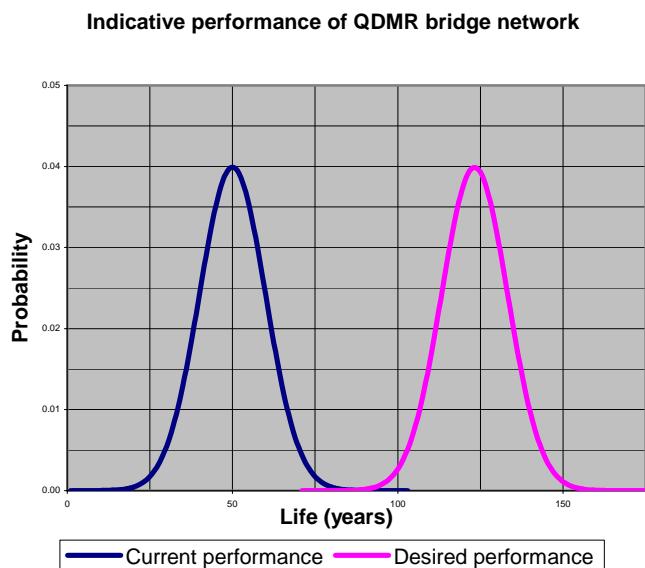
**Figure 1. Schematic view of bridge service and design lives**

Probably the dominant two issues have been (ii) and (iv). Optimised and improved concrete technology is needed to have an appreciable affect on (i) to (vii) inclusive. Hence, Road Authorities need to invest their first dollars available in understanding their local concretes and optimising the durability performance of the concrete and then look at other potential strategies. Fig. 1 shows a schematic representation of the actual histogram of bridge performance and the desired position. The average design life needs to shift to 125 years at least to guarantee a 1% failure criterion at 100 years. The Austroads Bridge Design Code (1992) requires a design life of 100 years.

The definition of design life in the Austroads Bridge Design Code does not mean that the bridge reaches its end of life at that age or that no maintenance is needed during its life. A regular normal maintenance plan should be undertaken to counter any localised distress due to construction defects or the affects of wear and abrasion. Fig. 2 shows a view of one of the few concrete bridges in Queensland which has met and exceeded the aims of the 1992 Bridge Code even though it was built in 1896 some 96 years before the Code was published.

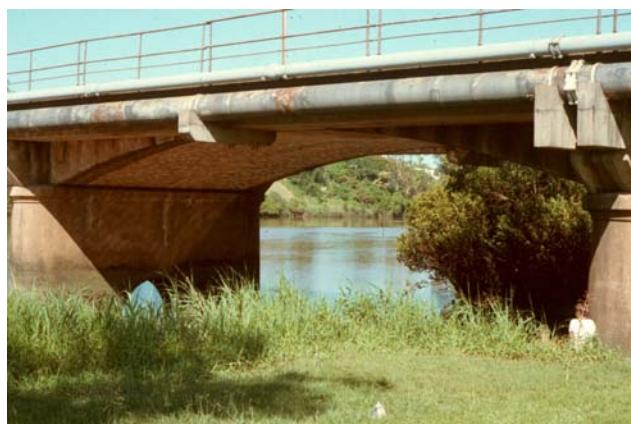
**Figure 2. View of Lamington Bridge built in 1896 now 107 years old**

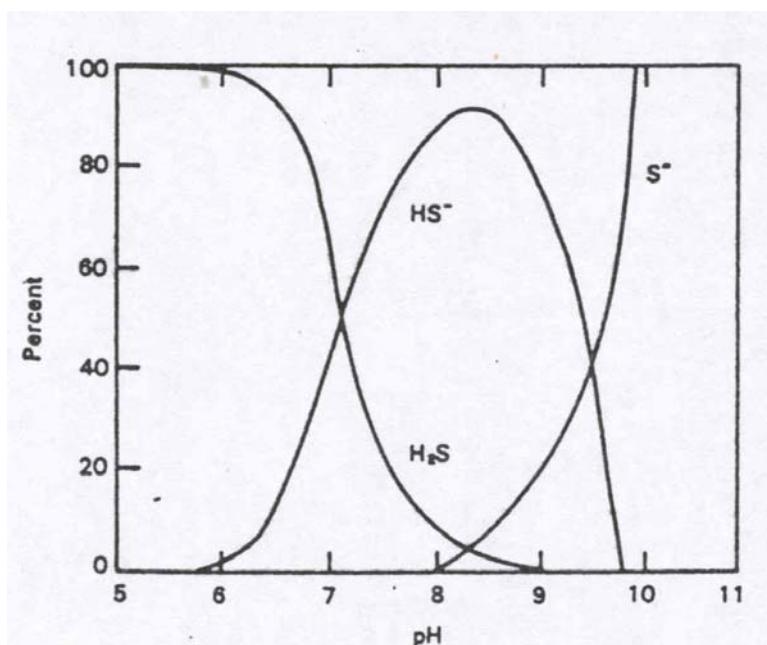
Figure 3. Effect of pH on hydrogen sulfide equilibrium

Dry pyrite exposed to air does not appear to oxidise. Equation 1 shows that both water and oxygen are needed similar to a corrosion reaction of steel in concrete. Bacterial action greatly speeds up the oxidation reaction as the solid pyrite is converted to sulfate and iron. For each mole of pyrite oxidised two moles of sulphuric acid are produced. The soil may have a self-buffering capacity due to calcium carbonate, shells, other carbonates or reaction with fine sediments. The lowest reported pH produced by pyritic oxidation of soil is around 1.3. When the pH drops the characteristic smell of hydrogen sulfide gas is an indication of the acidic conditions. Fig. 3 shows the equilibrium condition for hydrogen and sulfide with varying pH. As the pH drops the equilibrium diagram shows that all the sulfide will exist in the gaseous phase.

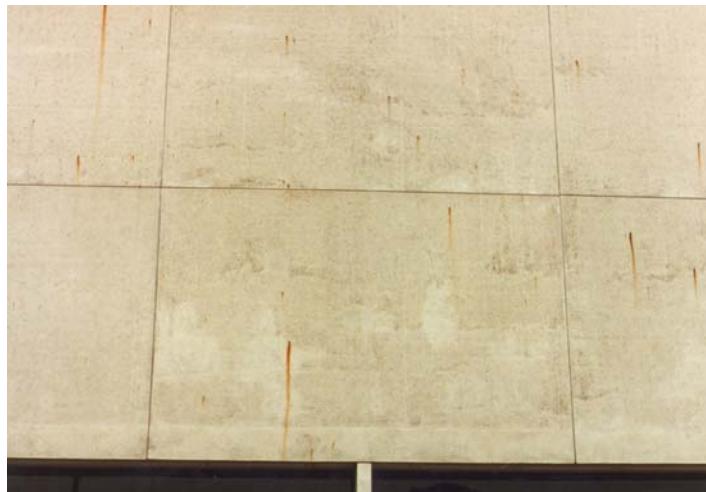
**Figure 4. View of pyrite staining on wall panel**

Some metamorphic and sedimentary source materials used for the production of crushed rock and aggregates may contain sulphides which can oxidise when exposed to the atmosphere to form deleterious and highly soluble acid salts. If crushed rock with a high sulfide content is used as a pavement material the dissolved acid salts will migrate to the asphalt/crushed rock interface where crystallisation will result in debonding of the surface layer. For concrete mix designs AS2758.1 requires that the total SO<sub>3</sub> content of the mix does not exceed 5% by mass of cement. Since approximately 3% of this allowance will already have been taken up by the gypsum in the cement this allows 2% for sulfide from all other sources. It should be noted that the only way to control this type of impurity is to ban the known sources. A good example of pyrite staining can be seen on the Cultural Centre building in Brisbane. Fig. 4 shows a view of the pyrite staining on the concrete walls. The oxidation process is a lot slower due to the larger crystal size of the pyrite and the lack of bacterial action.
