Repeat Photography using GigaPan Imagery in the San Simon Watershed, Arizona, USA

Proceedings of the Fine International Conference on Gigapixel Imaging for Science, .

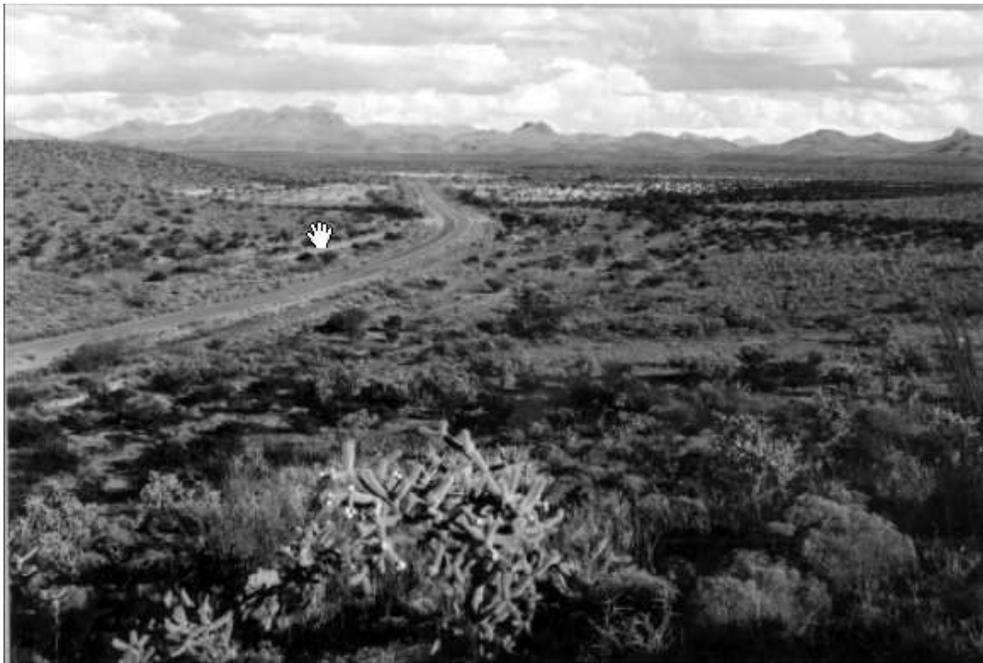
Figure 1. Looking east along the old Duncan Highway, San Simon Watershed, Arizona. This photo was taken October 21, 1941 by Berlyn B. Brixner. For zoomable version, <http://gigapan.org/gigapans/45580/>

In addition to vegetation over time, anthropogenic impacts can be identified through the photography. In 1941 the road between Safford and Duncan, AZ was paved as seen in image WS1-Ariz-RS-161. The road depicted in the 1941 photo is the Safford Duncan Highway, one of the first paved highways in Graham and Greenlee Counties. The old Safford Duncan Highway can still be traveled and it is quite a scenic route traveled by visitors of the Public Lands in Arizona. As depicted in the 2010 photo, much of the original asphalt pavement is gone with the passage of 70 years.

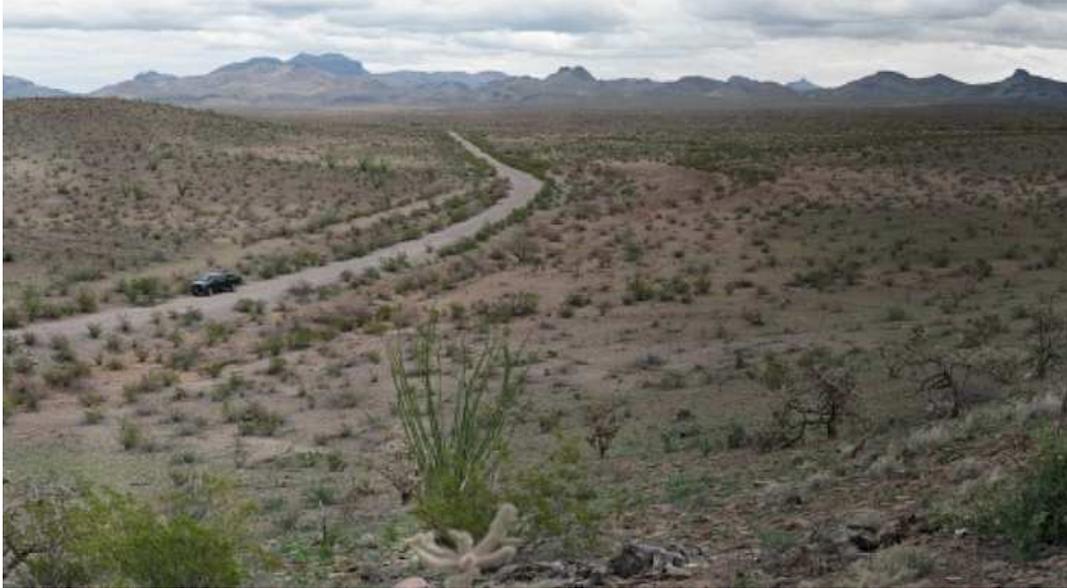
Figure 2. A 2010 view of the landscape shown in Figure 1 taken using the GigaPan system. For zoomable version, <http://gigapan.org/gigapans/45569/>
