International Soil and Water Conservation Research

Original Research Article

Unintended consequences of rangeland conservation structures

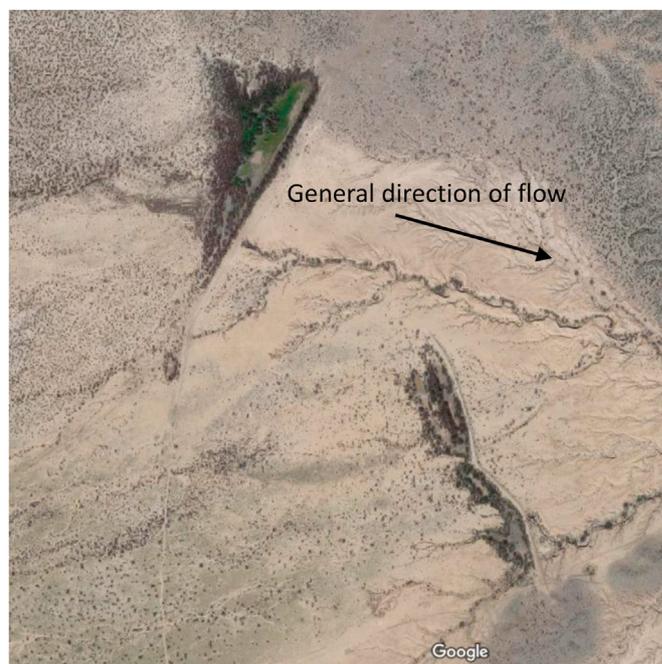
Fig. 1. Vegetation on upslope side of water spreader berms. Image sourced from Google Earth.

Recently, rangeland water spreading has received renewed attention, and the effectiveness of water spreader berms for creating “islands” of enhanced soil moisture and primary productivity has been documented (Rango et al., 2006). In a 2009 review of water harvesting applications for rangelands, Rango & Havstad, 2009 present support for the use of such techniques in dryland conservation. Clearly, water spreading can produce localized, positive vegetative responses (Fig. 1).

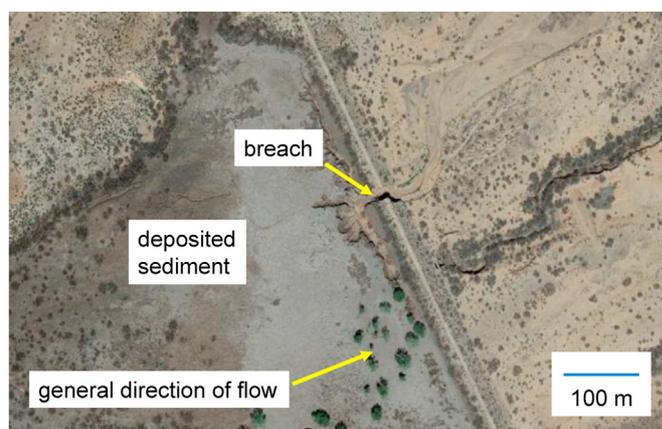
Fig. 5. Breached H X Dam and gully advance into accumulated sediment.

We evaluated the structural condition of contour berms and earthen water spreaders based on aerial photographs, lidar data, and site visits. Structures and associated breaches (breaks through a structure) and flanks (scour around a structure) were identified by visually inspecting 2016 aerial imagery sourced from Google Earth. Structures were digitized and measured within Google Earth. A comprehensive analysis of the larger in-channel dams is beyond the scope of this study, but we include a summary of a specific breach at the H X Dam, which was constructed in 1956 across a tributary within the San Simon subwatershed, as an example of the potential impact of the failure of larger conservation structures (Fig. 5).

The 8 m high 1200 m long H X Dam breached in 2014 and exemplifies the threat associated with the failure of larger structures. Although a 5.2M earthquake centered near Duncan, Arizona and the aftershocks that followed are suspected to be the direct cause of the breach, deferred maintenance may have played a role in the failure (W. Brandau, personal experience). Estimates by the BLM indicate that prior to the breach approximately 750,800 metric tons of sediment could have been stored behind the dam. The breach initiated gullying and the release of stored sediment to downstream river segments threatening to exceed the Total Maximum Daily Load for suspended sediment allowed to enter the Gila River (USDA NRCS 2007). The breach also defeated the flood control function of the dam. In this case, the threat of damage to downstream property, roads, and the water quality of the river justified repair of the dam. However, in the absence of eminent threats to safety, property, or environmental regulations in populated areas, many such dam breaches are not repaired, thus gullying and sediment release continue unchecked.
